## REPORT NO. 96-13

# NEW MANUFACTURERS OF WOODEN PALLETS UTILIZING MECHANICAL NAILERS MIL-STD-1660 TESTS

Prepared for:  
U.S. Army Armament Research, Development  
and Engineering Center  
ATTN: AMSTA-AR-ESK  
Rock Island, IL 61299-7300

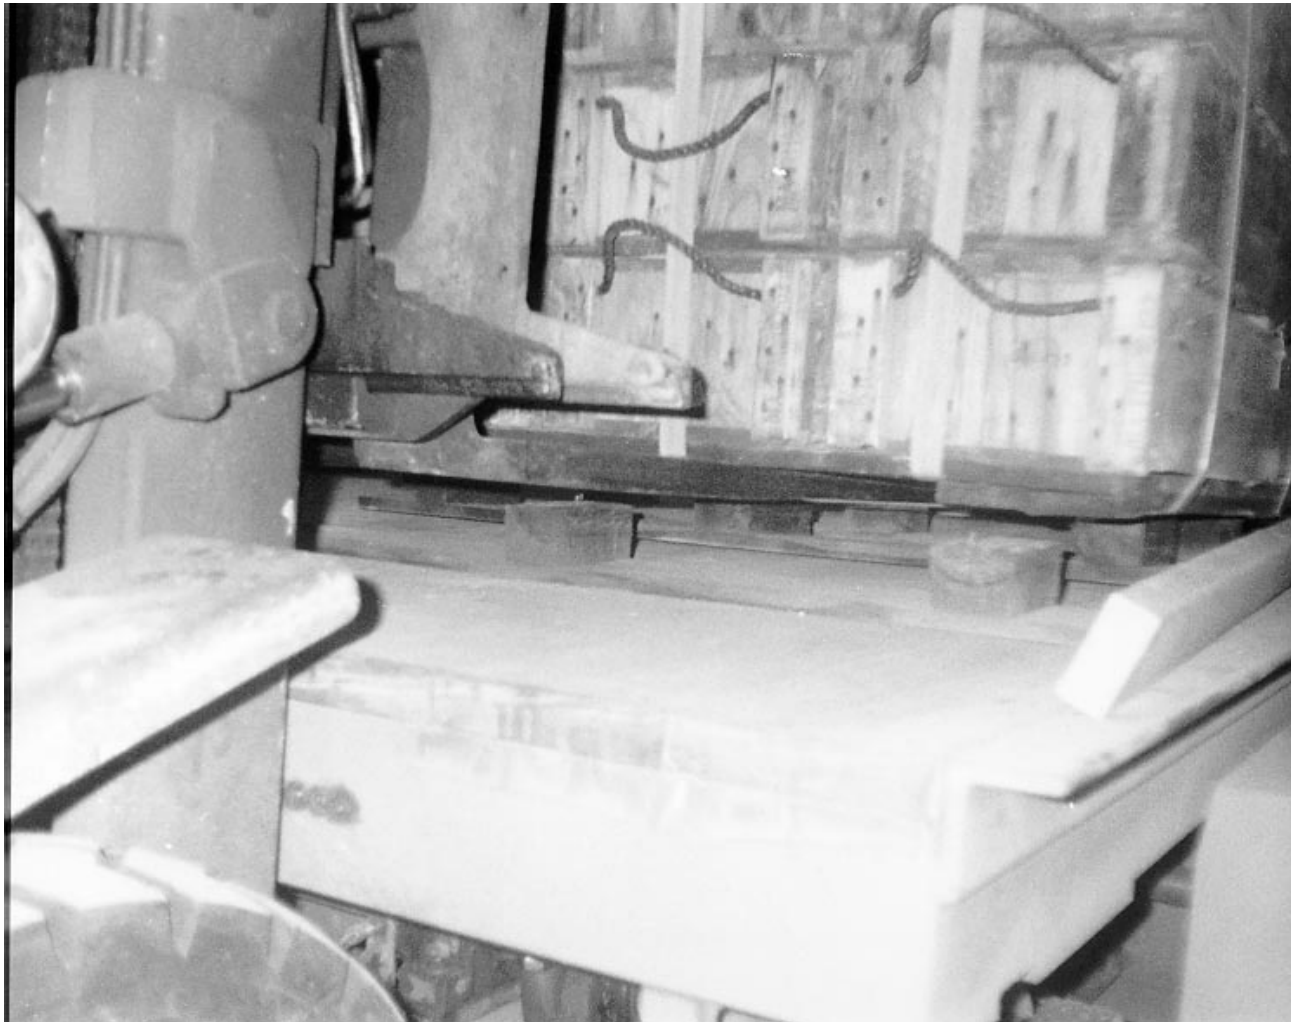
USADACS-DEV-96-13-01. This photo shows Madison County Wood Products, Inc. pallet no. 2 on the vibration table. The front skid came loose from the deck.		
---	--	--

C. REPETITIVE SHOCK TEST. The duration of the test was 90 minutes for each orientation of the pallet. The transportation simulator was operated for each pallet IAW Table 1 on page 5-2. One steel strap on pallet no. 1 broke from rubbing against the bar that holds the pallet on the vibration table. The band was replaced and testing was continued. One of the corner posts on pallet no. 1 was twisted slightly while the pallet was being removed from the transportation simulator. The lateral orientation of vibration for pallet no. 2 caused one of the outside skids to release from the posts completely, as 7 of the 9 nails fastening the skid to the posts were sheared off (see Part 6, page 6-2). The longitudinal vibration of pallet no. 3 caused one corner of one of the side skids to come loose from the post. The lateral orientation of vibration caused the nails fastening the deck to the post to shear off at one corner of the pallet (see Part 6, page 6-3).

F. END OF TEST INSPECTION. Pallet no. 1 completed testing with only one post twisted. The damage to pallets nos. 2 and 3 was severe enough to discontinue testing following the repetitive shock test. Pallet no. 2 had the nails fastening the deck to one post of the other outside skid shear off. No additional damage was noted on pallet no. 3.

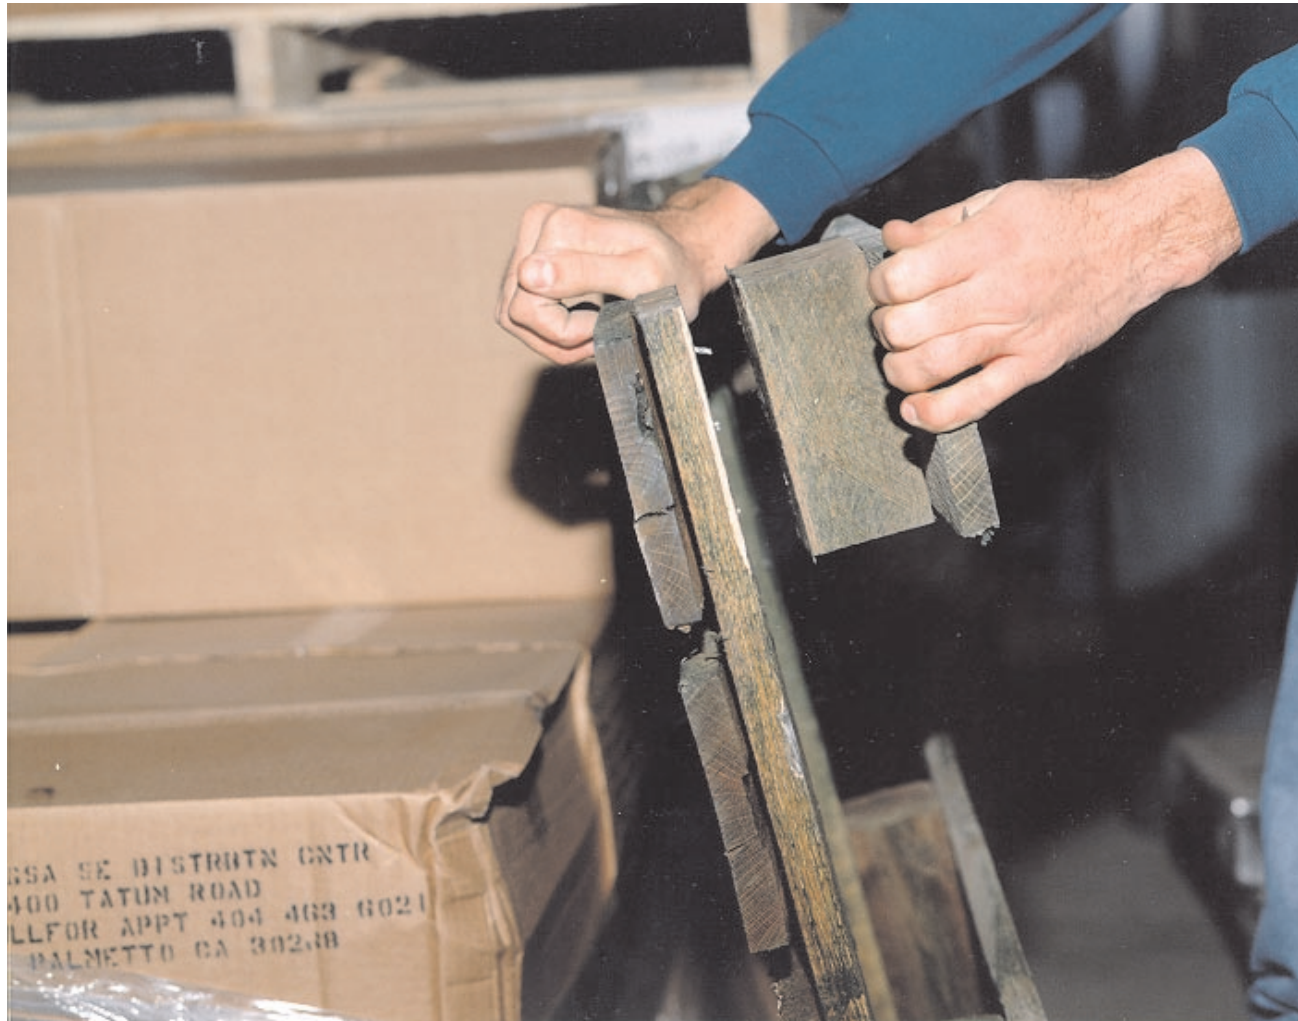
AO317-SCN96-37-834. This photo shows the nails attaching the deck to the post sheared off causing one corner of Madison County Wood Products, Inc. pallet no. 3 to become loose.		
--	--	--

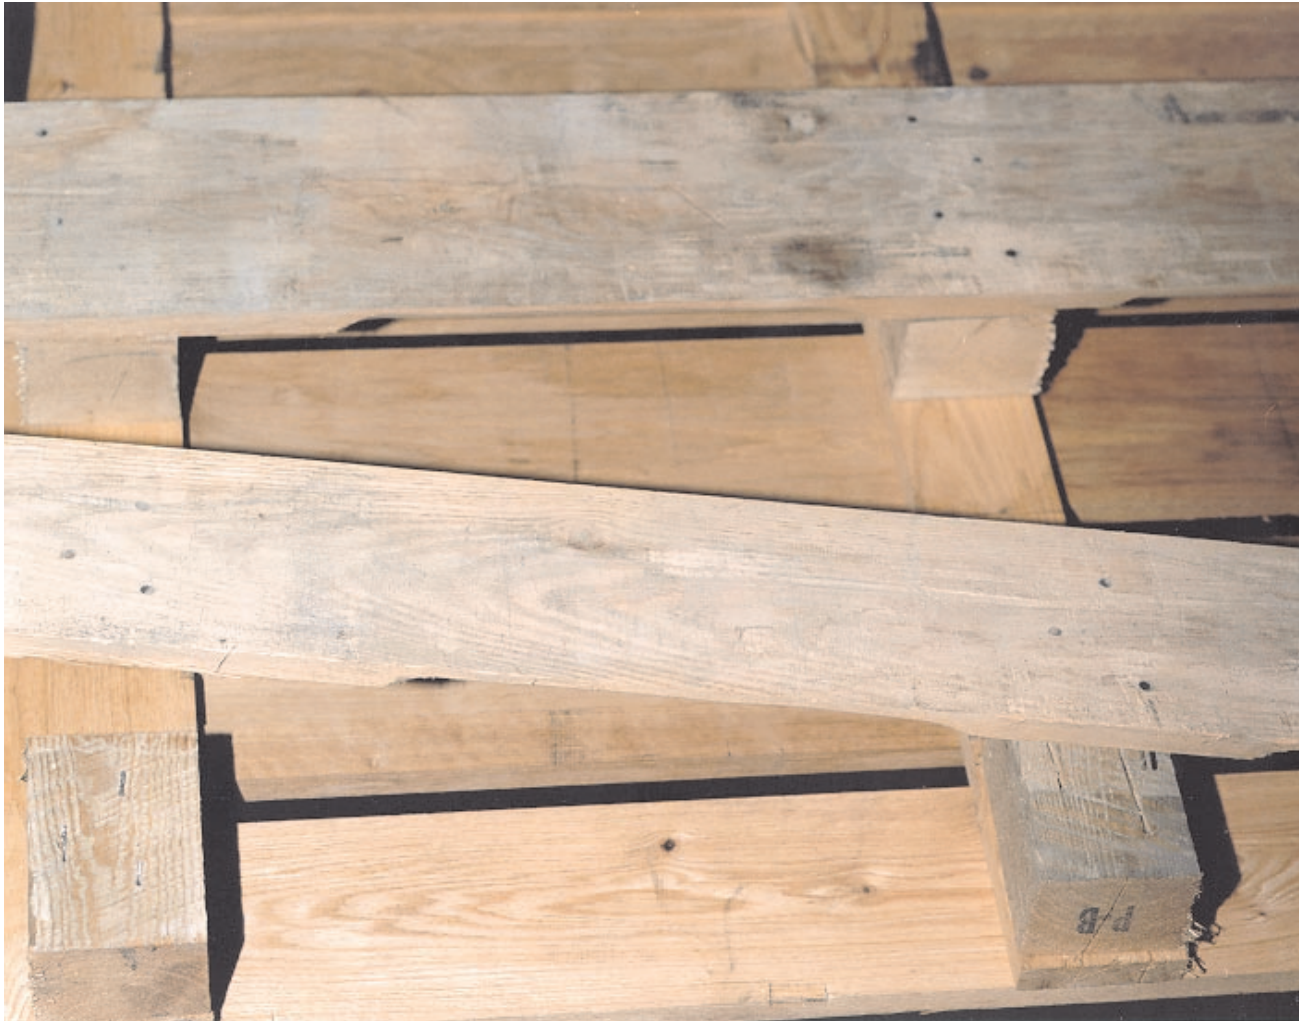
AO317-SCN96-37-836. This photo shows the detached outside skid of Stewart's Forest Products, Inc. pallet no. 4.		
---	--	--

F. END OF TEST INSPECTION. Samples nos. 4 and 5 had nails attaching the skid to the post shear off, causing portions of the pallet to become disassembled. Sample no. 6 completed testing with a slight separation between the deck and the post. The apparent cutting in of the strap in sample no. 6 was a result of the pallet being cracked prior to testing.

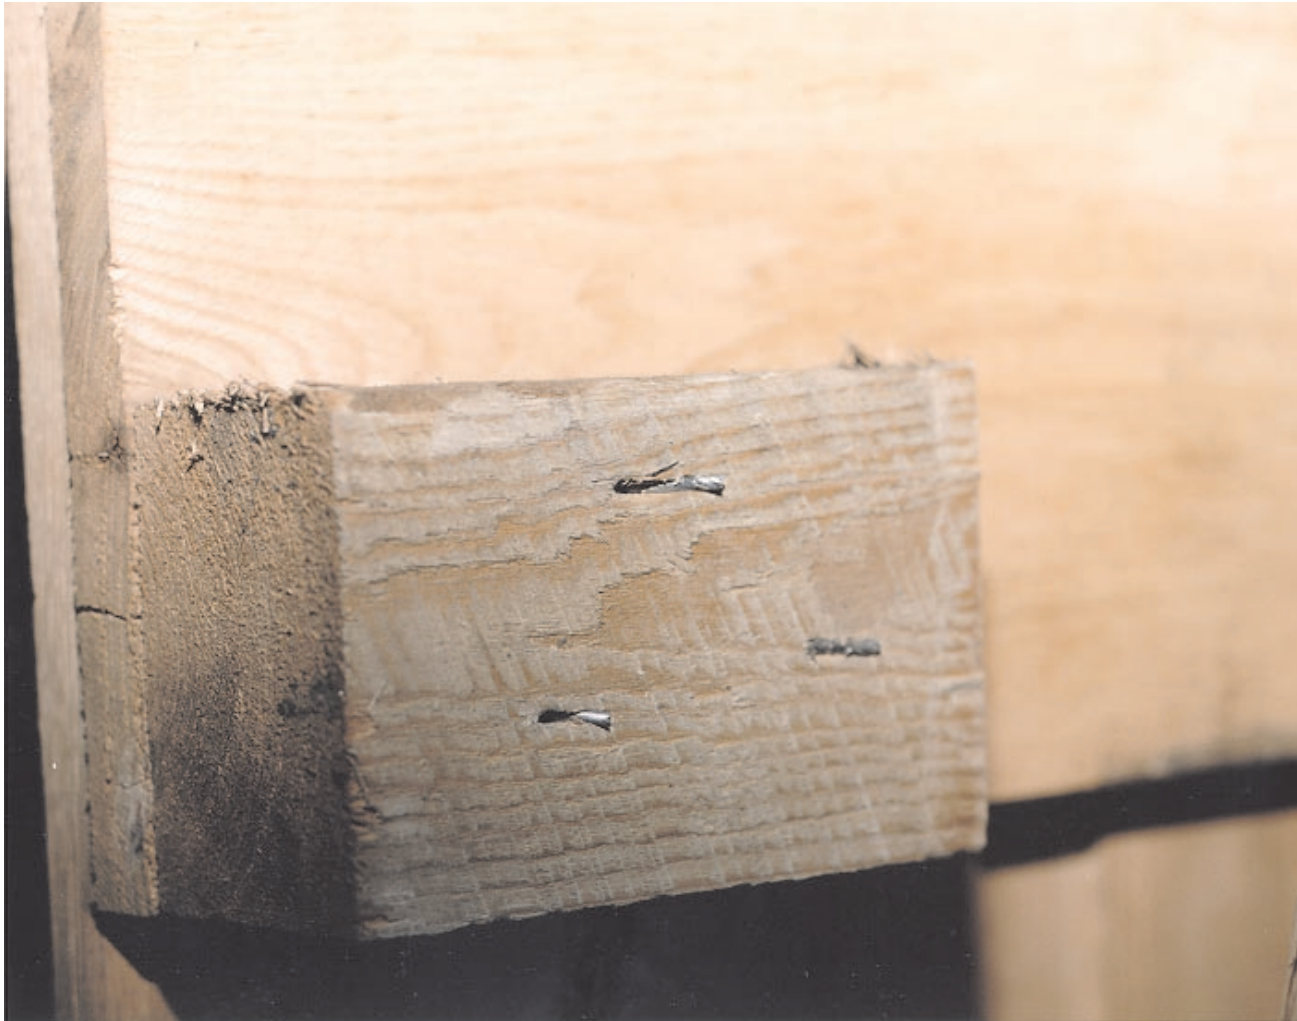
AO317-SCN96-37-837. This photo shows the sheared off nails that attached the skid to the post of Stewart's Forest Products, Inc. pallet no. 4.		
--	--	--

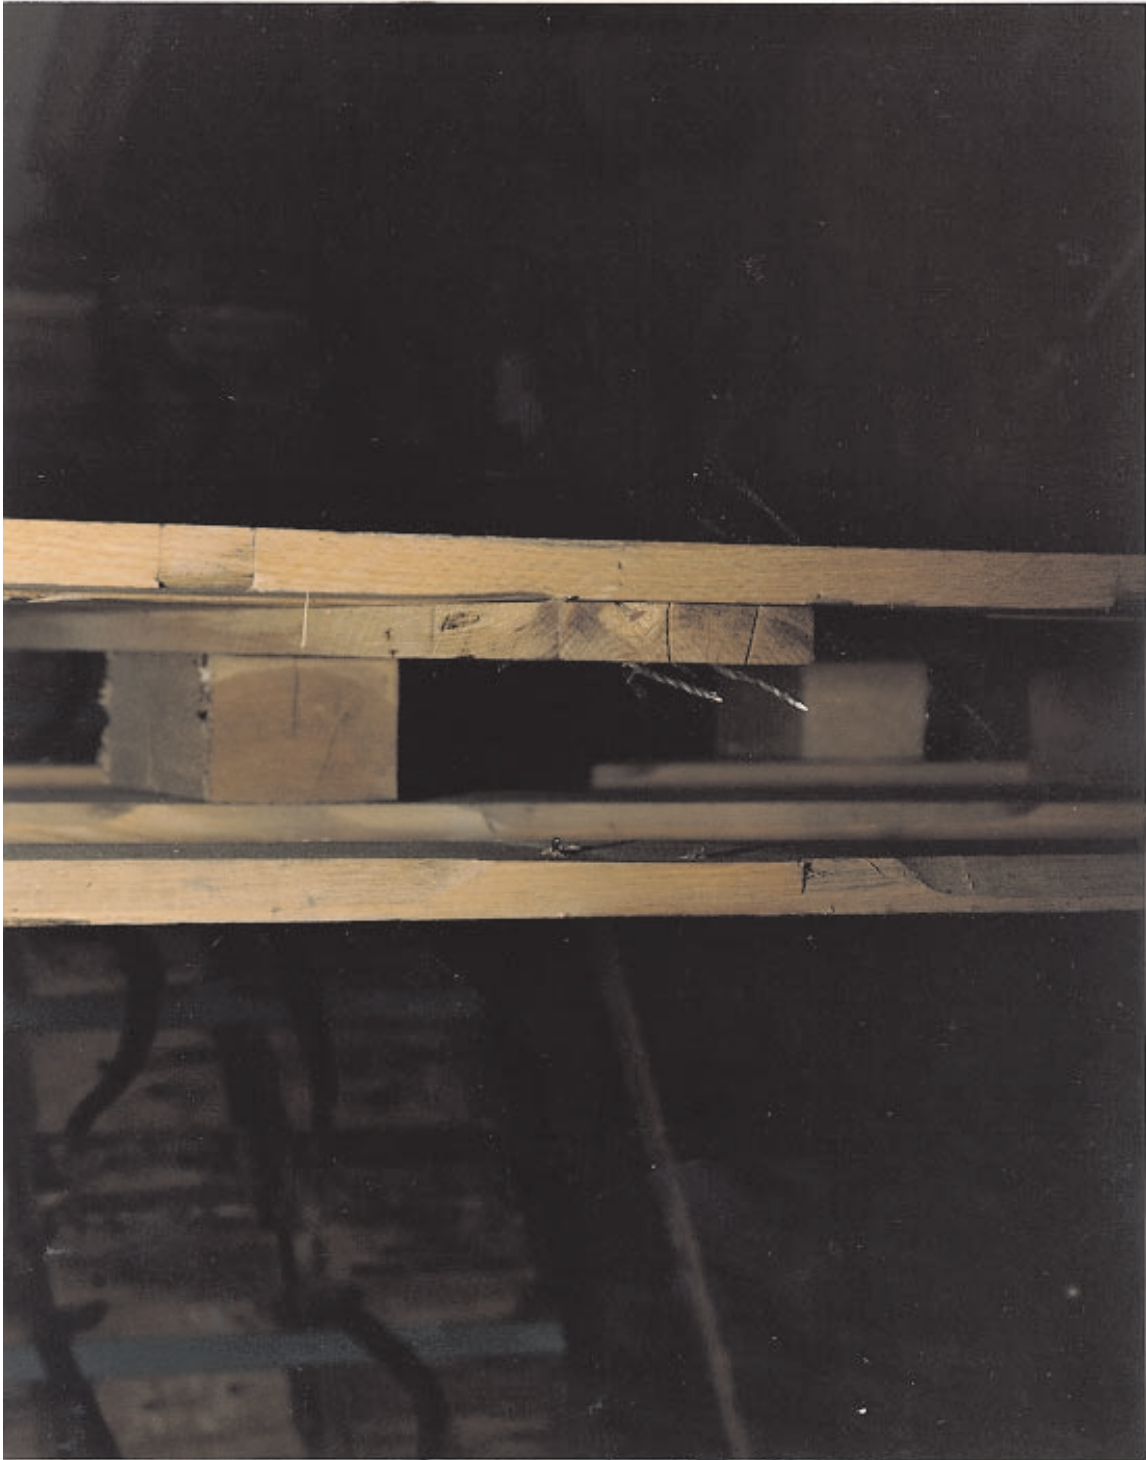
U.S. ARMY DEFENSE AMMUNITION CENTER AND SCHOOL - SAVANNA, IL	
AO317-SCN96-37-838. This photo shows the location where one of the posts of Stewart's Forest Products, Inc. pallet no. 5 pulled away from during the edgewise rotational drop test.

D. EDGEWISE ROTATIONAL DROP TEST. Each side of the pallet was placed on a beam displacing it 4-1/2 inches above the floor. The opposite end of the pallet was raised to a height of 12 inches, then dropped. While raising pallet S5 for the final drop, the previously rotated block pulled away from the pallet, as one of the nails through the skid sheared off while the other 3 bent over and the 3 nails through the deck into the post bent over (see Part 6, page 6-8). No further damage resulted to the other test samples.

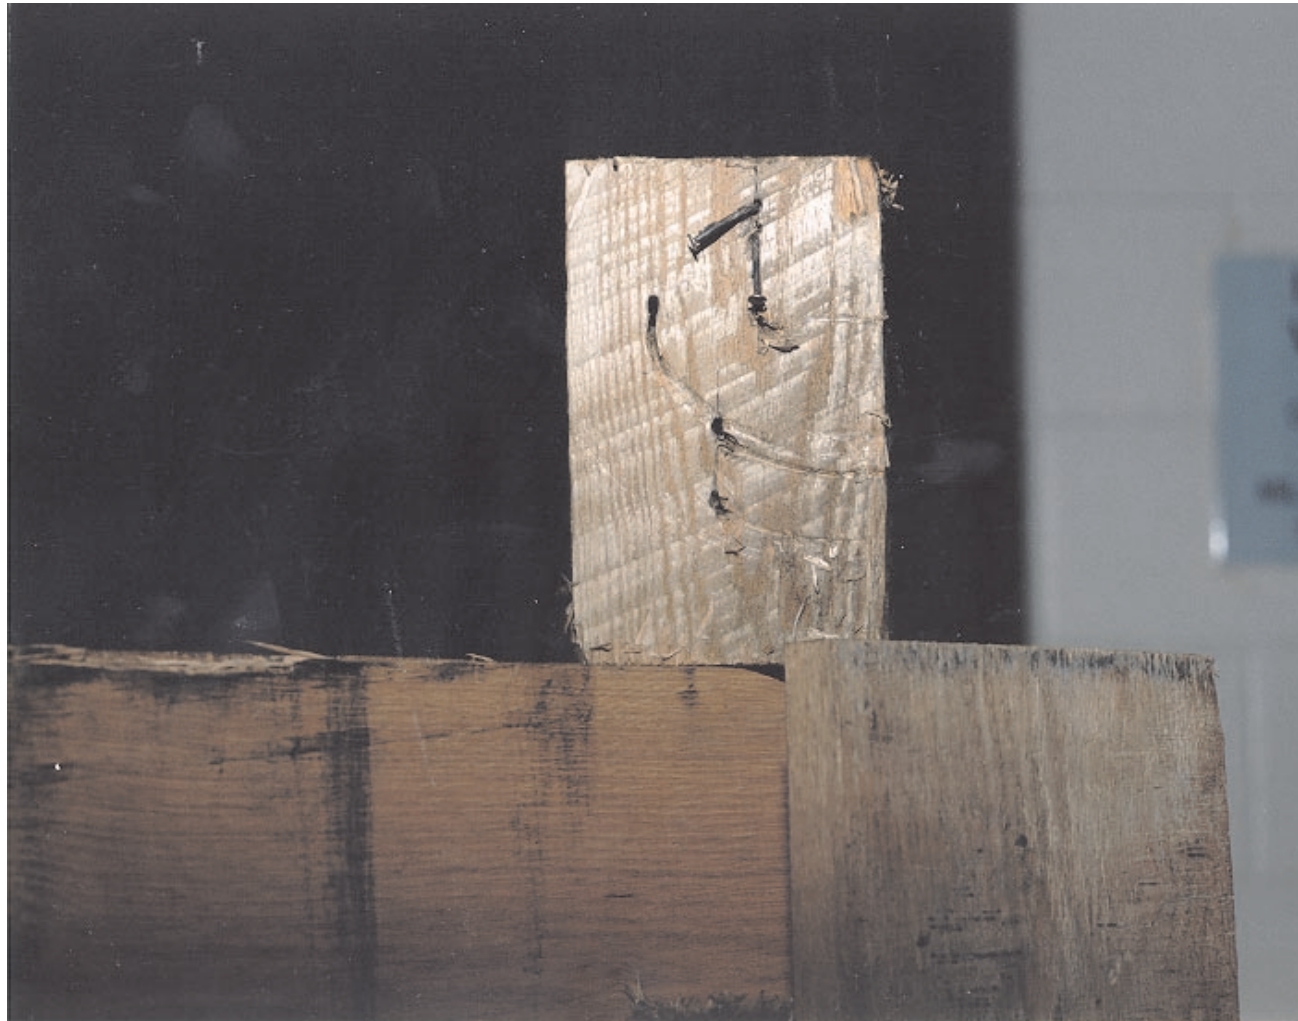
AO317-SCN96-37-830. This photo shows the top of the block that pulled away from Stewart's Forest Products, Inc. pallet no. 5. Note the 2 nails present that pulled through the stringer board and deck.		
---	--	--

F. END OF TEST INSPECTION. Sample S5 had only one nail shear off and the rest of the nails pulled out. The rest of the posts in this pallet, as well as the other samples, remained secure. Sample S4 had cracks along the strapping slot in deck boards extending inward 2-1/2-inches.

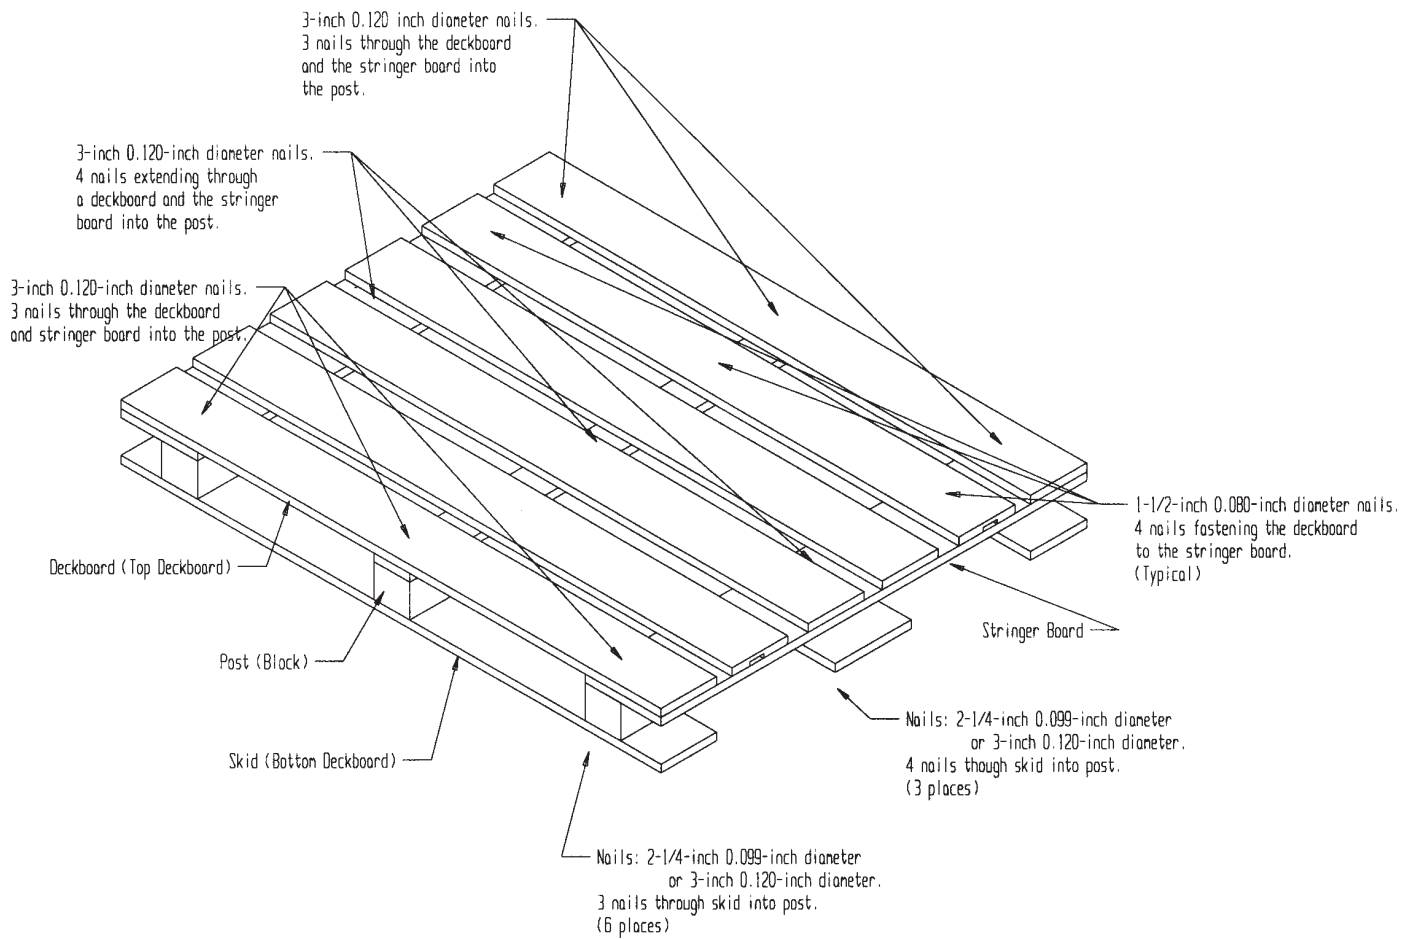
42 Inch X 53 Inch Pallet  
 Nails are those used by  
 Stewart's Forest Products, Inc.
